Re: Pre-Enforcement Notice  
Lamb Weston, Inc.  
**2022-PEN-6829**  
File 48780, WPCF 101326  
Umatilla County

Appendix: "Groundwater Review: A review of groundwater data and water level elevations at Lamb Weston North Farm and Madison Ranch Land Application Sites through August 2021"

Subject: **Groundwater Review:** A review of groundwater data and water level elevations at Lamb Weston North Farm and Madison Ranch Land Application Sites through August 2021

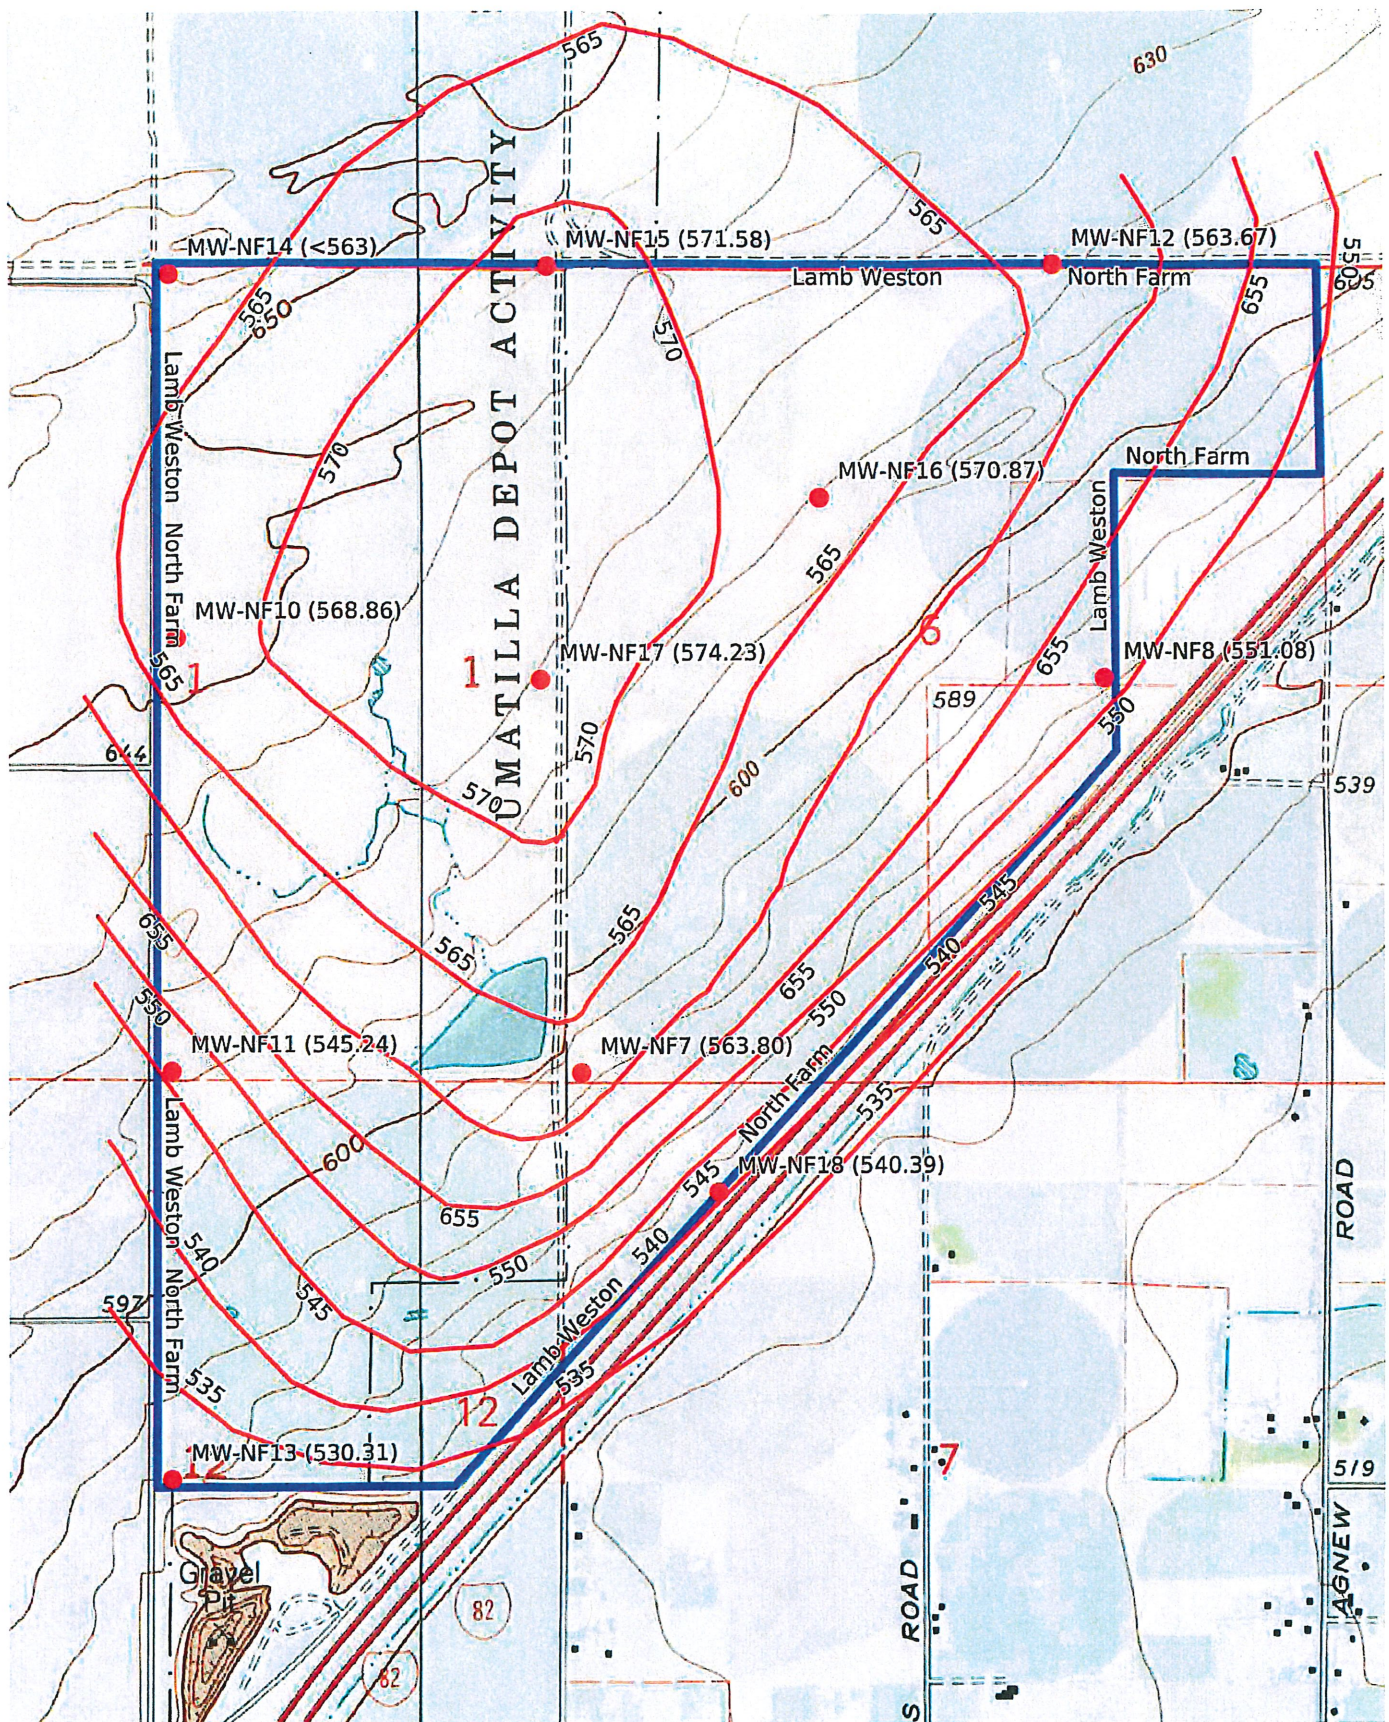
Figure 1.

The addition of the new wells at the North Farm shows a clear groundwater mound beneath the site. Prior to the addition of data from monitoring wells MW-NF14, MW-NF15, MW-NF16, MW-NF17 and MW-NF18; the well with the highest nitrate concentrations and groundwater elevation was MW-NF12. With MW-NF12 having the highest elevation it appeared that groundwater was flowing to the south at that point. However, with the new wells, MW-NF16 and MW-NF17 are at a higher elevation and the data now show groundwater flowing from the two new wells towards MW-NF12. The highest groundwater elevation observed at the site is at monitoring well MW-NF17. I contoured the August 2021 water level data for all the shallow wells at the site and a digitized version is attached (Figure 1). The contours show an obvious groundwater mound, which means groundwater is flowing away from the high point in all directions. The monitoring wells around the perimeter of the site have increasing nitrate trends, except for MW-NF11. The perimeter monitoring wells have recent nitrate concentrations ranging from 36.0 mg/l at MW-NF18 to 78.5 mg/l at MW-NF12. All the perimeter wells indicate excessive groundwater contamination is migrating off the site in all directions (Figure 2). The only perimeter well with a decreasing trend is MW-NF11. The trends are apparent in Figure 3, which illustrates the lowest trend lines for the perimeter wells. Water level contours on Figure 1 show groundwater is migrating off site in all directions. This indicates that the source of nitrate at all perimeter wells is coming from the site. Since nearly all the site perimeter wells are increasing this further suggests ongoing practices at the site are contributing to the nitrate migrating off the site at the North Farm. The nitrate concentrations in groundwater migrating off the site range between 36 and 79

mg/l. These levels are more than three to seven times higher than MCL of 10 mg/l. This indicates the land application practices are severely impacting groundwater beneath the land application sites at the North Farm.

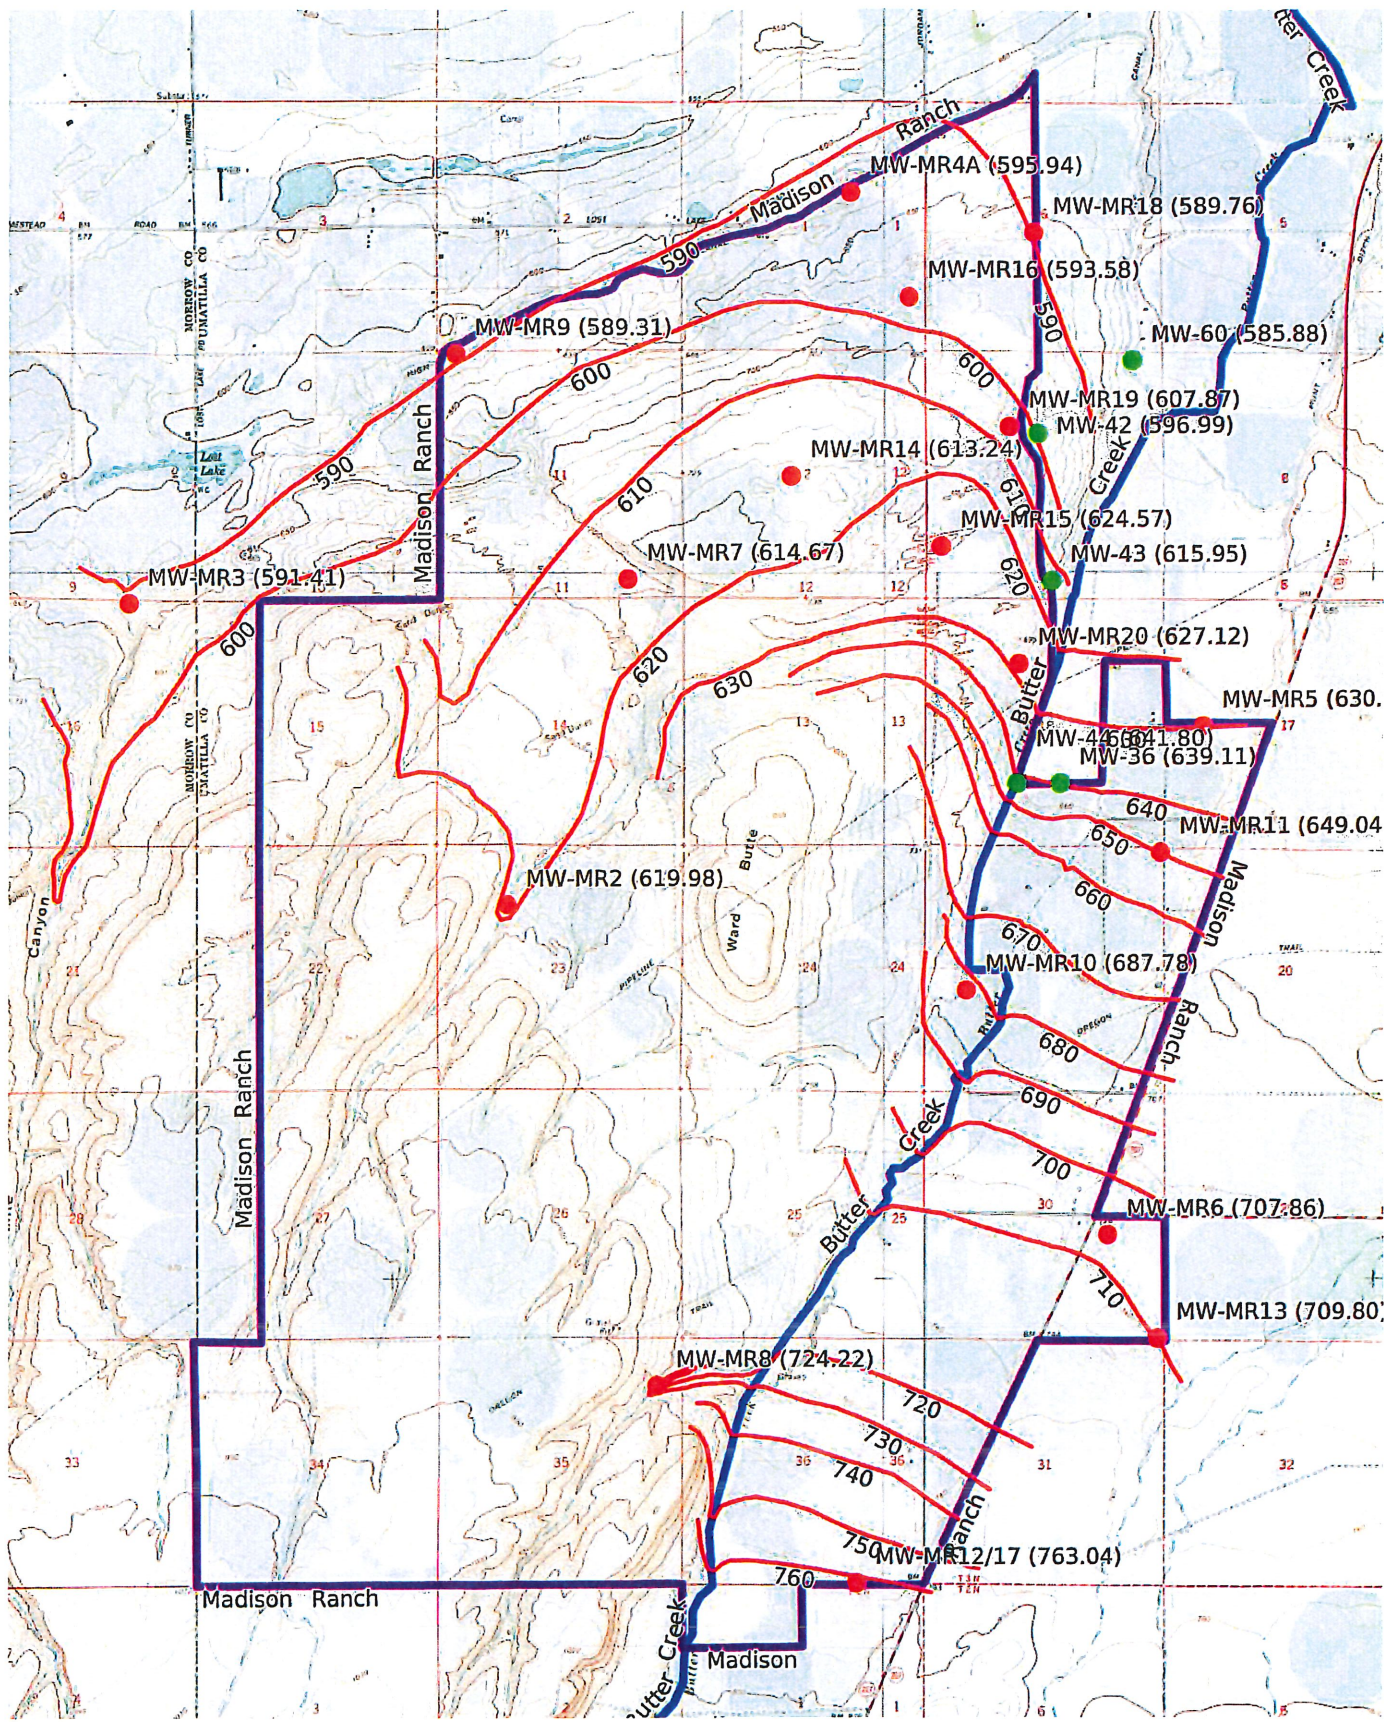
Figure 4.

The additional monitoring wells at the Lamb Weston Madison Ranch site also helped refine the direction of groundwater flow. I contoured the August groundwater data using water level information from all Madison Ranch wells and augmented that August water levels from nearby Simplot wells MW-36, MW-42, MW-43, MW-44, and MW-60 (Figure 4). In general, groundwater flow at the Madison Ranch site is flowing north-northeast down the Butter Creek flood plain and in the upland areas the flow appears to follow topography in a radial pattern with flow to the northeast into the Butter Creek flood plain along the eastern side of the upland, more north in the central portion of the upland and northwest along the western side of the farm (Figure 4). Based on these flow directions there are at least seven downgradient wells along the northern and northeastern boundary of the Madison Ranch application site. Downgradient monitoring wells along these boundaries include monitoring wells MW-MR3, MW-MR4A, MW-MR5, MW-MR6, MW-MR9, MW-MR18, MW-MR-19, and MW-MR20. In the last couple of years, five of these eight well have exceeded the maximum contaminant level (MCL) of 10 mg/l for nitrate. Monitoring well MW-MR6 is along the southeastern edge of the site about 1.5 miles north-northwest of the upgradient monitoring well MW-MR17/12. While this well has not been designated a downgradient compliance well in the past, the water level contours indicate groundwater is leaving the site at that location. Monitoring well MR6 has the second highest concentrations on the site with the most recent nitrate concentration of 26.7 mg/l.

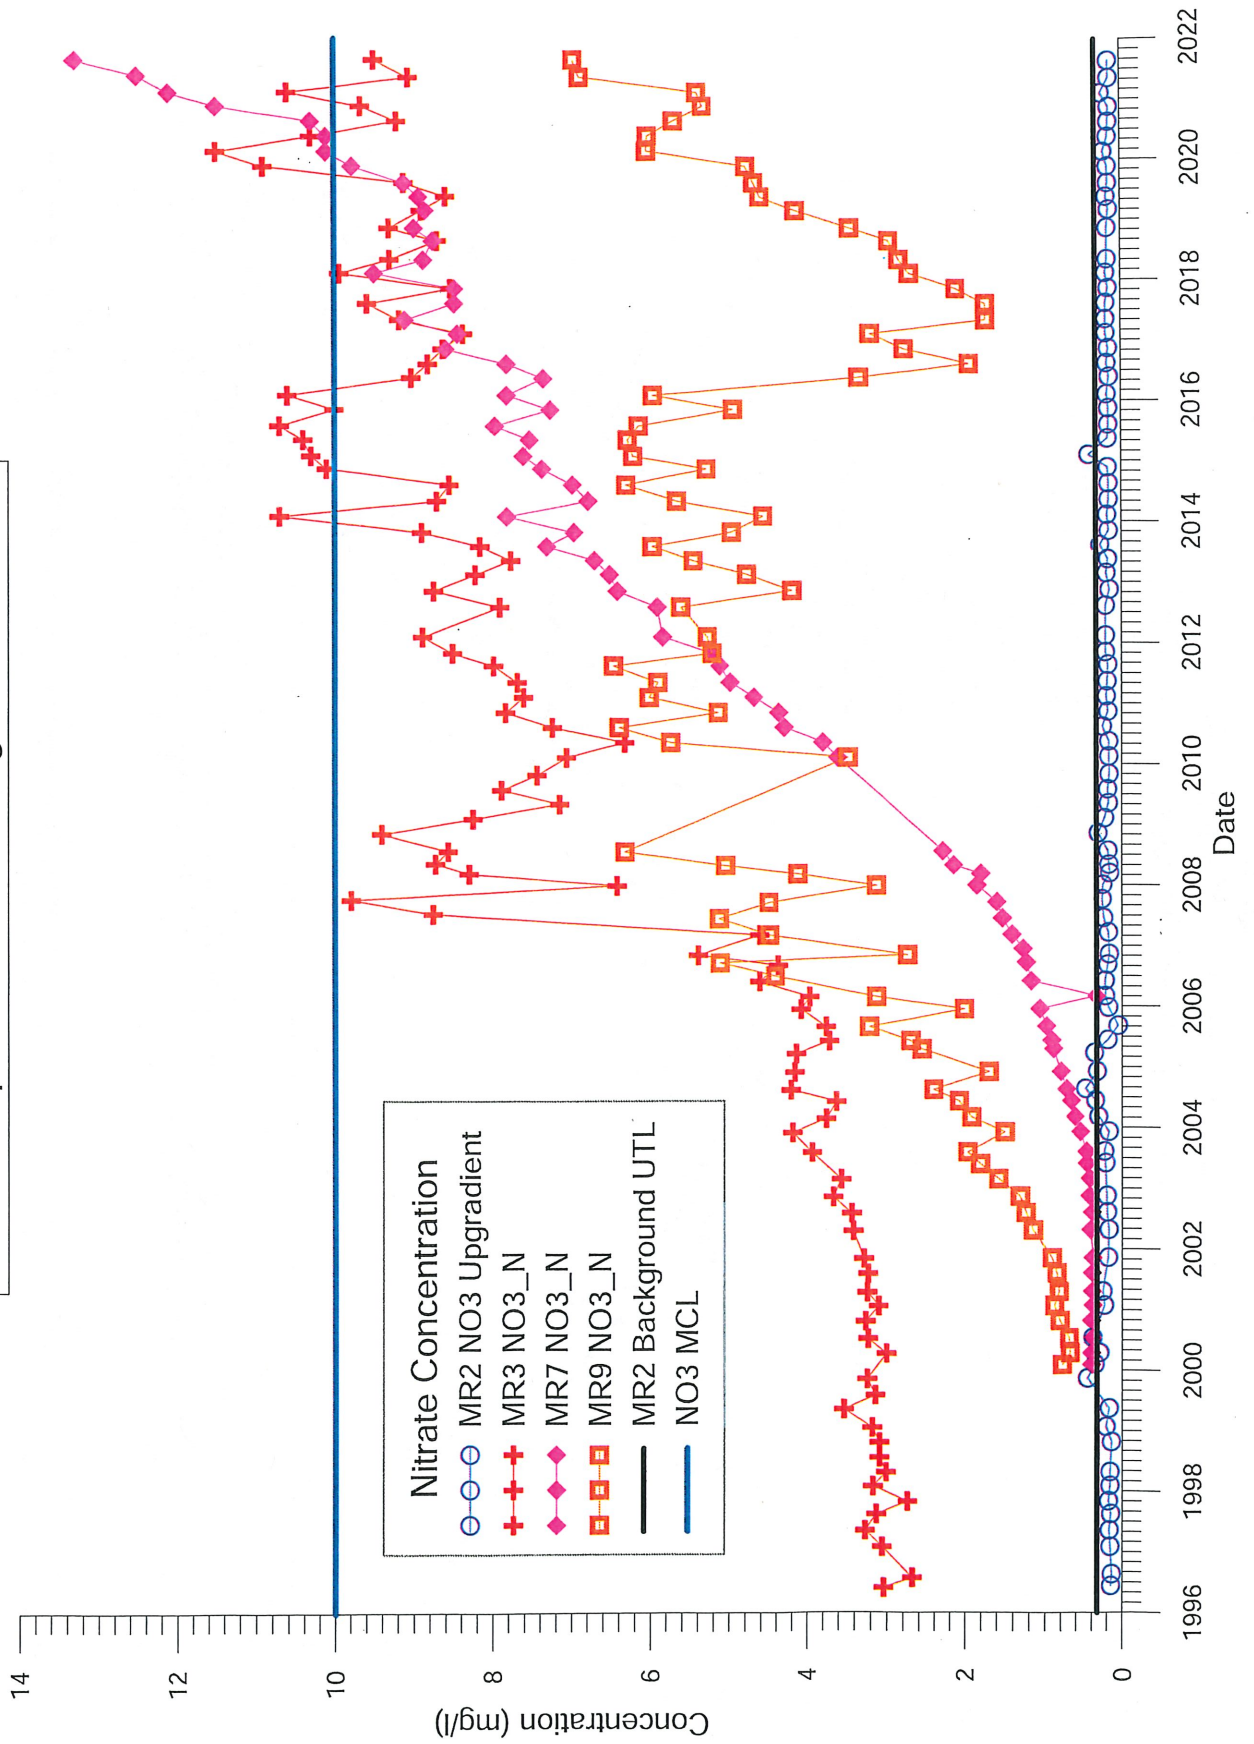
Figure 5  
 Lamb Weston Madison Ranch  
 Western Upland Wells Downgradient of MR2

The water quality at MW-MR2 has very little nitrate present throughout the years and can likely be used as a surrogate background well. Monitoring well MW-MR2 is likely representative of background water quality for the western portion of the uplands. Three monitoring wells that are generally downgradient of MW-MR2 include MW-MR3, MW-MR7, and MW-MR9. All three of these wells have nitrate concentrations that climbed to levels that are significantly higher than MW-MR2 and have significant increasing trends. Monitoring well MW-MR7 is an interior well in the uplands that started with concentrations similar to those seen in MW-MR2 but has shown a dramatic and steady increase since land application began in the uplands. Monitoring well MW-MR3 is in a drainage a little farther to the west and nitrate concentrations started a little higher than those from MW-MR2, but there is a clear and significant upward trend. Monitoring well MW-MR3 has shown a steady increase and in recent years has exceeded the MCL for nitrate. Lamb Weston recently transferred the circles closest to MW-MR3 to the Port of Morrow, but the upward trends and exceedance of the nitrate MCL occurred while this area was still in Lamb Weston's monitoring program. Monitoring well MW-MR9 also shows an overall increasing trend and like MW-MR7 started out with concentrations similar to those seen at MW-MR2 (Figure 5).

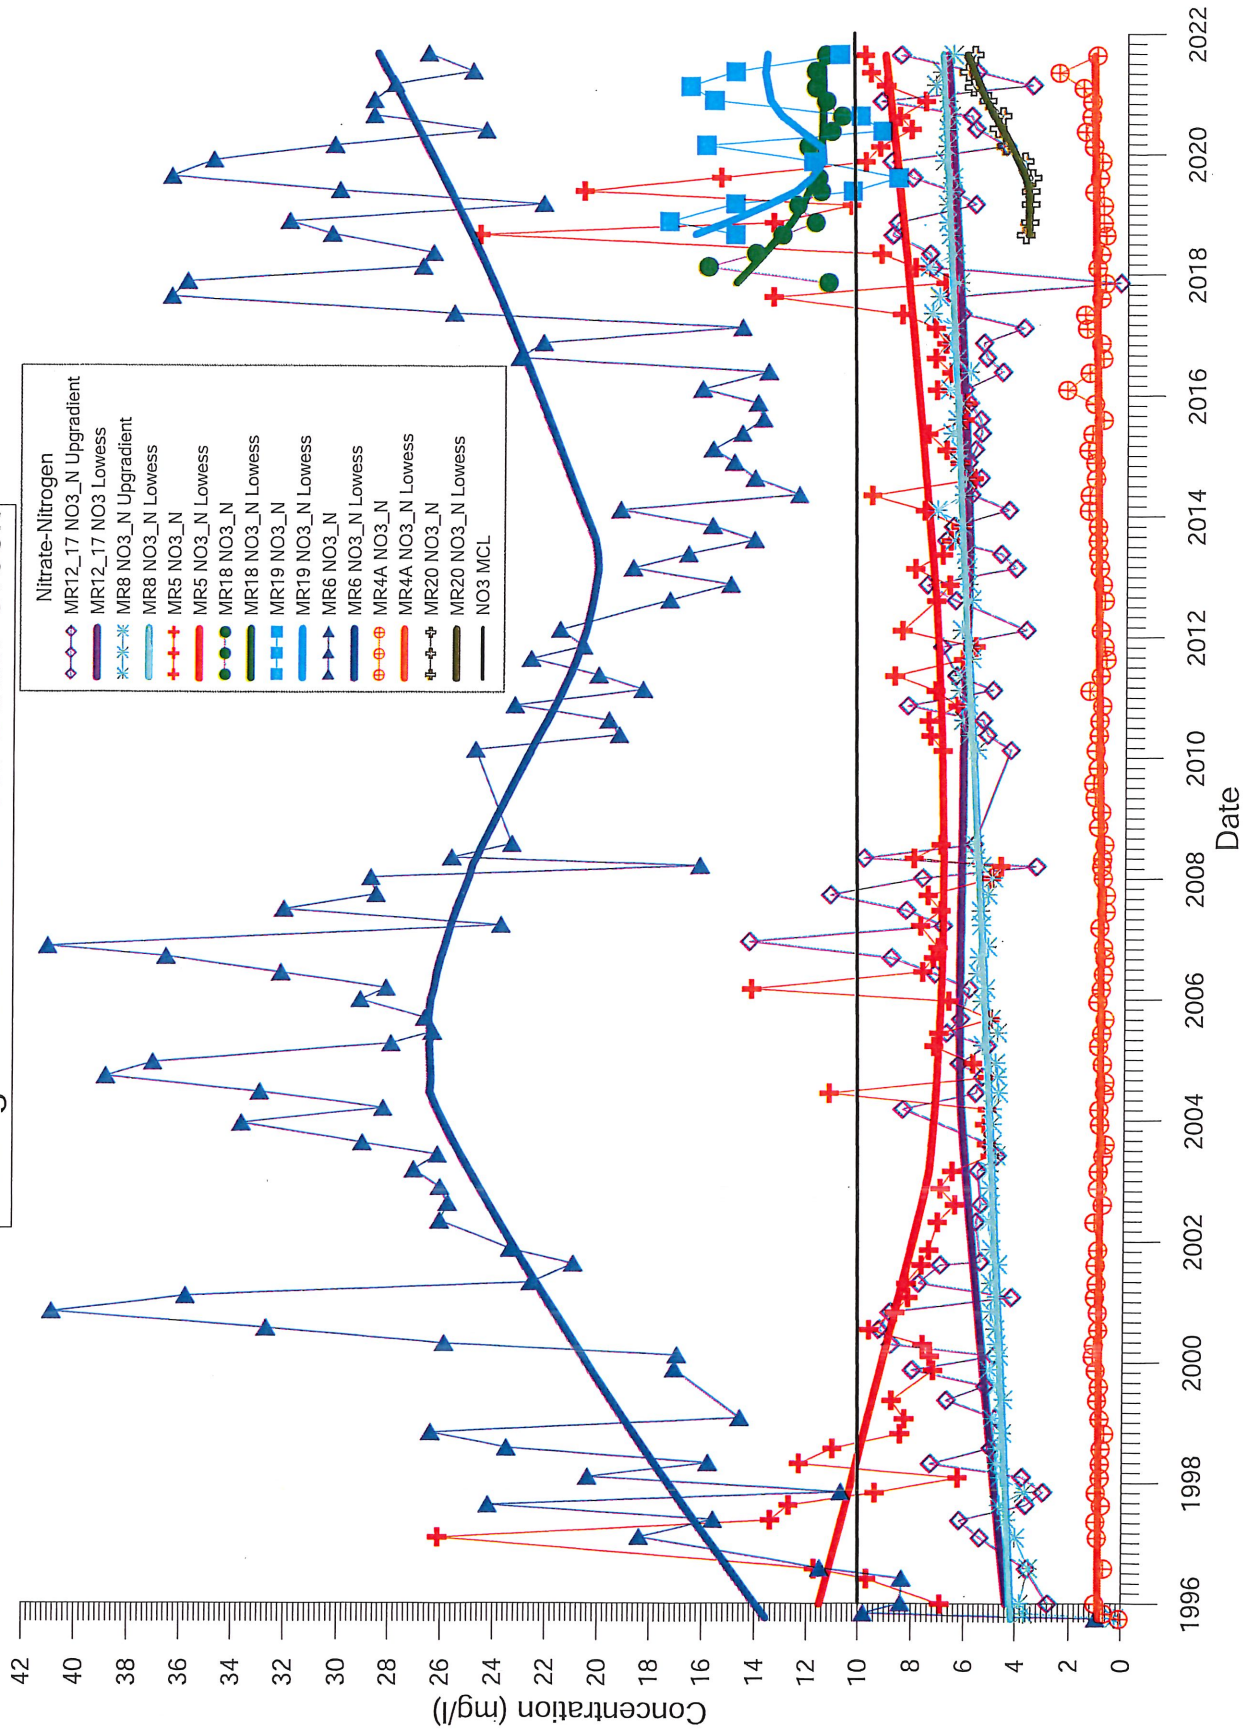
Figure 6  
 Lamb Weston Madison Ranch  
 Downgradient Wells Near Butter Creek

Monitoring wells that are downgradient of MW-MR17/12 and MW-MR8 include monitoring wells along the north and east sides of the site such as MW-MR4A, MW-MR5, MW-MR6, MW-MR18, MW-MR19, and MW-MR20 (Figure 6). Four of these six wells (MW-MR5, MW-MR6, MW-MR18 and MW-MR19) have exceeded the MCL of 10 mg/l for nitrate at least once in the last 2 years. The other two downgradient wells MW-MR4A and MW-MR20 have not exceeded the nitrate-nitrogen MCL of 10 mg/l. Monitoring wells MW-MR4A and MW-MR20 are close the High Line Canal and Butter Creek, respectively and are likely being diluted from low concentration surface water. These are the only downgradient wells with concentrations less than the upgradient wells. All Madison downgradient wells in the Butter Creek Flood Plain area have increasing nitrate trends, except for monitoring well MW-MR18. Even though MW-MR18 does not have an increasing trend, nitrate concentrations in samples from this well are consistently

above the MCL for nitrate. Monitoring wells MW-MR5, MW-MR6, MW-MR18 and MW-MR19 consistently have higher concentrations than either of the upgradient wells. This indicates practices at the facility are contributing nitrate to the groundwater at the site. Moreover, nitrate contaminated groundwater appears to be leaving the site at MW-MR5, MW-MR6, MW-MR18 and MW-MR19 at levels more than the background or the MCL for nitrate.

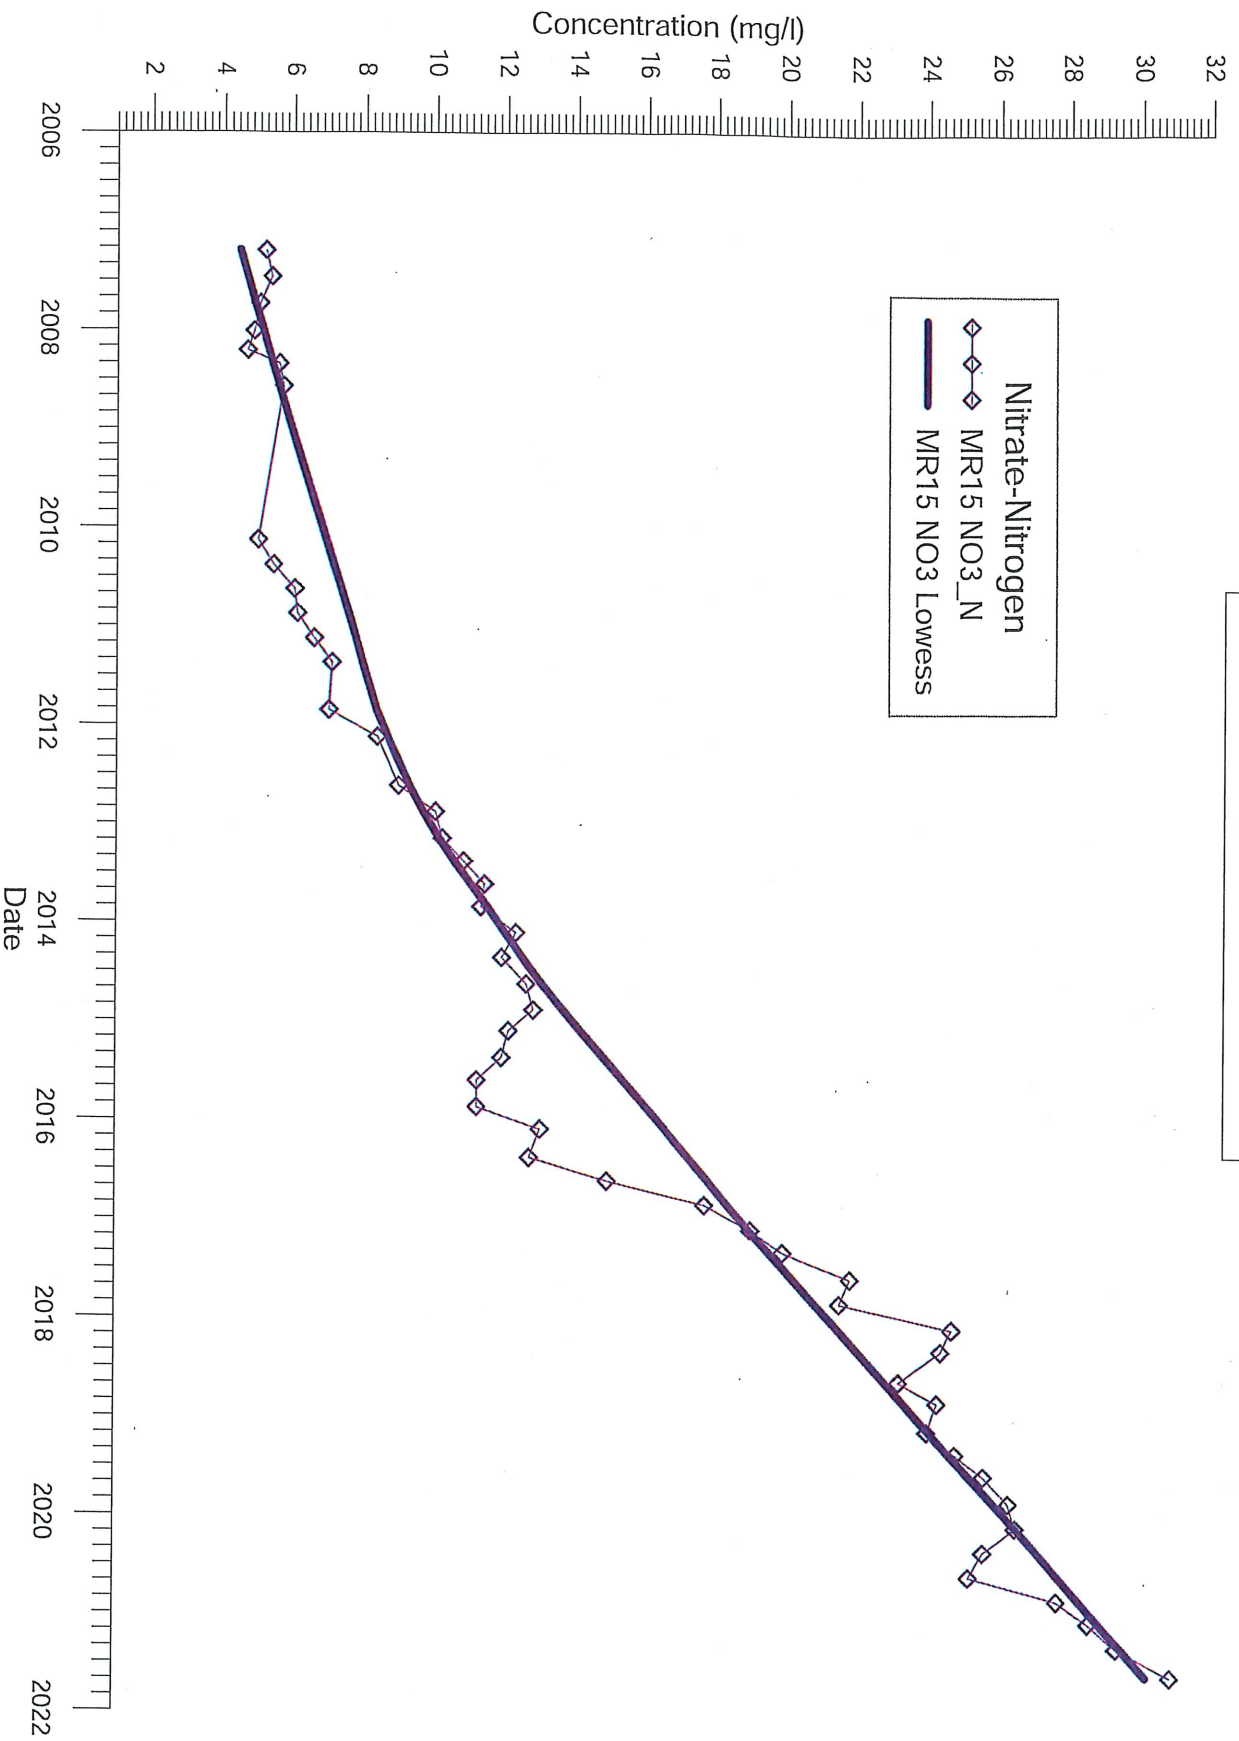
Figure 7  
Lamb Weston Madison Ranch  
MR15 NO<sub>3</sub> Concentrations

The monitoring well with the highest nitrate concentration at the site is interior well MW-MR15. Concentrations at this well have been steadily increasing since it was installed in 2007 and recently exceeded 30 mg/l (Figure 7). This is at least three times any observed background concentrations. The data indicate that practices on the land application site are impacting groundwater at excessive levels.
