KELLER AUDITORIUM

SEISMIC ANALYSIS SUMMARY

March 2020

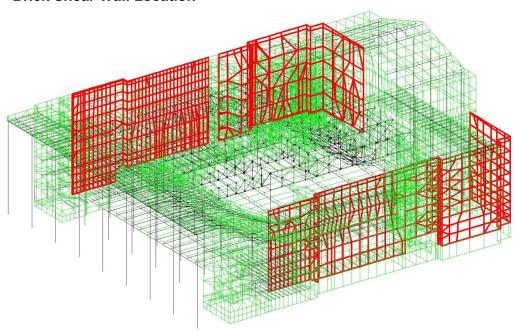
Brick Shear Wall Location

The model was used to test the building's structural capacity in close to 600 different mode scenarios to develop an understanding of its behavior. The model produced loads in all the walls that were used as lateral resistance elements and, even though the walls added in 1966 are more rigid, a significant portion of the lateral load is transferred to the 1917 brick masonry exterior walls. The modeling demonstrated that the structure of the building, in its current configuration is vulnerable to failure in a number of different seismic scenarios.

The modeling demonstrated that the structure of the building, in its current configuration is vulnerable to failure in a number of different seismic scenarios.

To help understand a rough order of magnitude of the necessary upgrades, Miller developed an engineering cost estimate. This estimate was based on repairs to strengthen the concrete and masonry walls adding reinforced pneumatically placed concrete to the inside face of the wall to resist the missing shear capacity, as well as provide additional out-of-plane capacity. Masonry partition walls were expected to either be braced or removed and replaced with metal stud walls.
